RE: AZS Chemical Company (a.k.a. Cargill)
Atlanta, Fulton County, Georgia
Preliminary Assessment Report

**PRELIMINARY ASSESSMENT
AZS CHEMICAL CO. (a.k.a. CARGILL)
762 MARIETTA BLVD. N.W.
ATLANTA, FULTON COUNTY, GEORGIA
EPA ID #s GAD981237225 & GAD057288144**

Photo	1 of 45	Date:	09/24/2007	Site Name:	AZS Corporation		
Photographer:	Thomas J Brodell, QEP; HWMB			City:	Atlanta	County:	Fulton
Explanation:	MW-1, the designated background well. Currently used as a bathroom facility by indigents living on property as indicated by partially decomposed toilet paper around well. Well found unlocked.

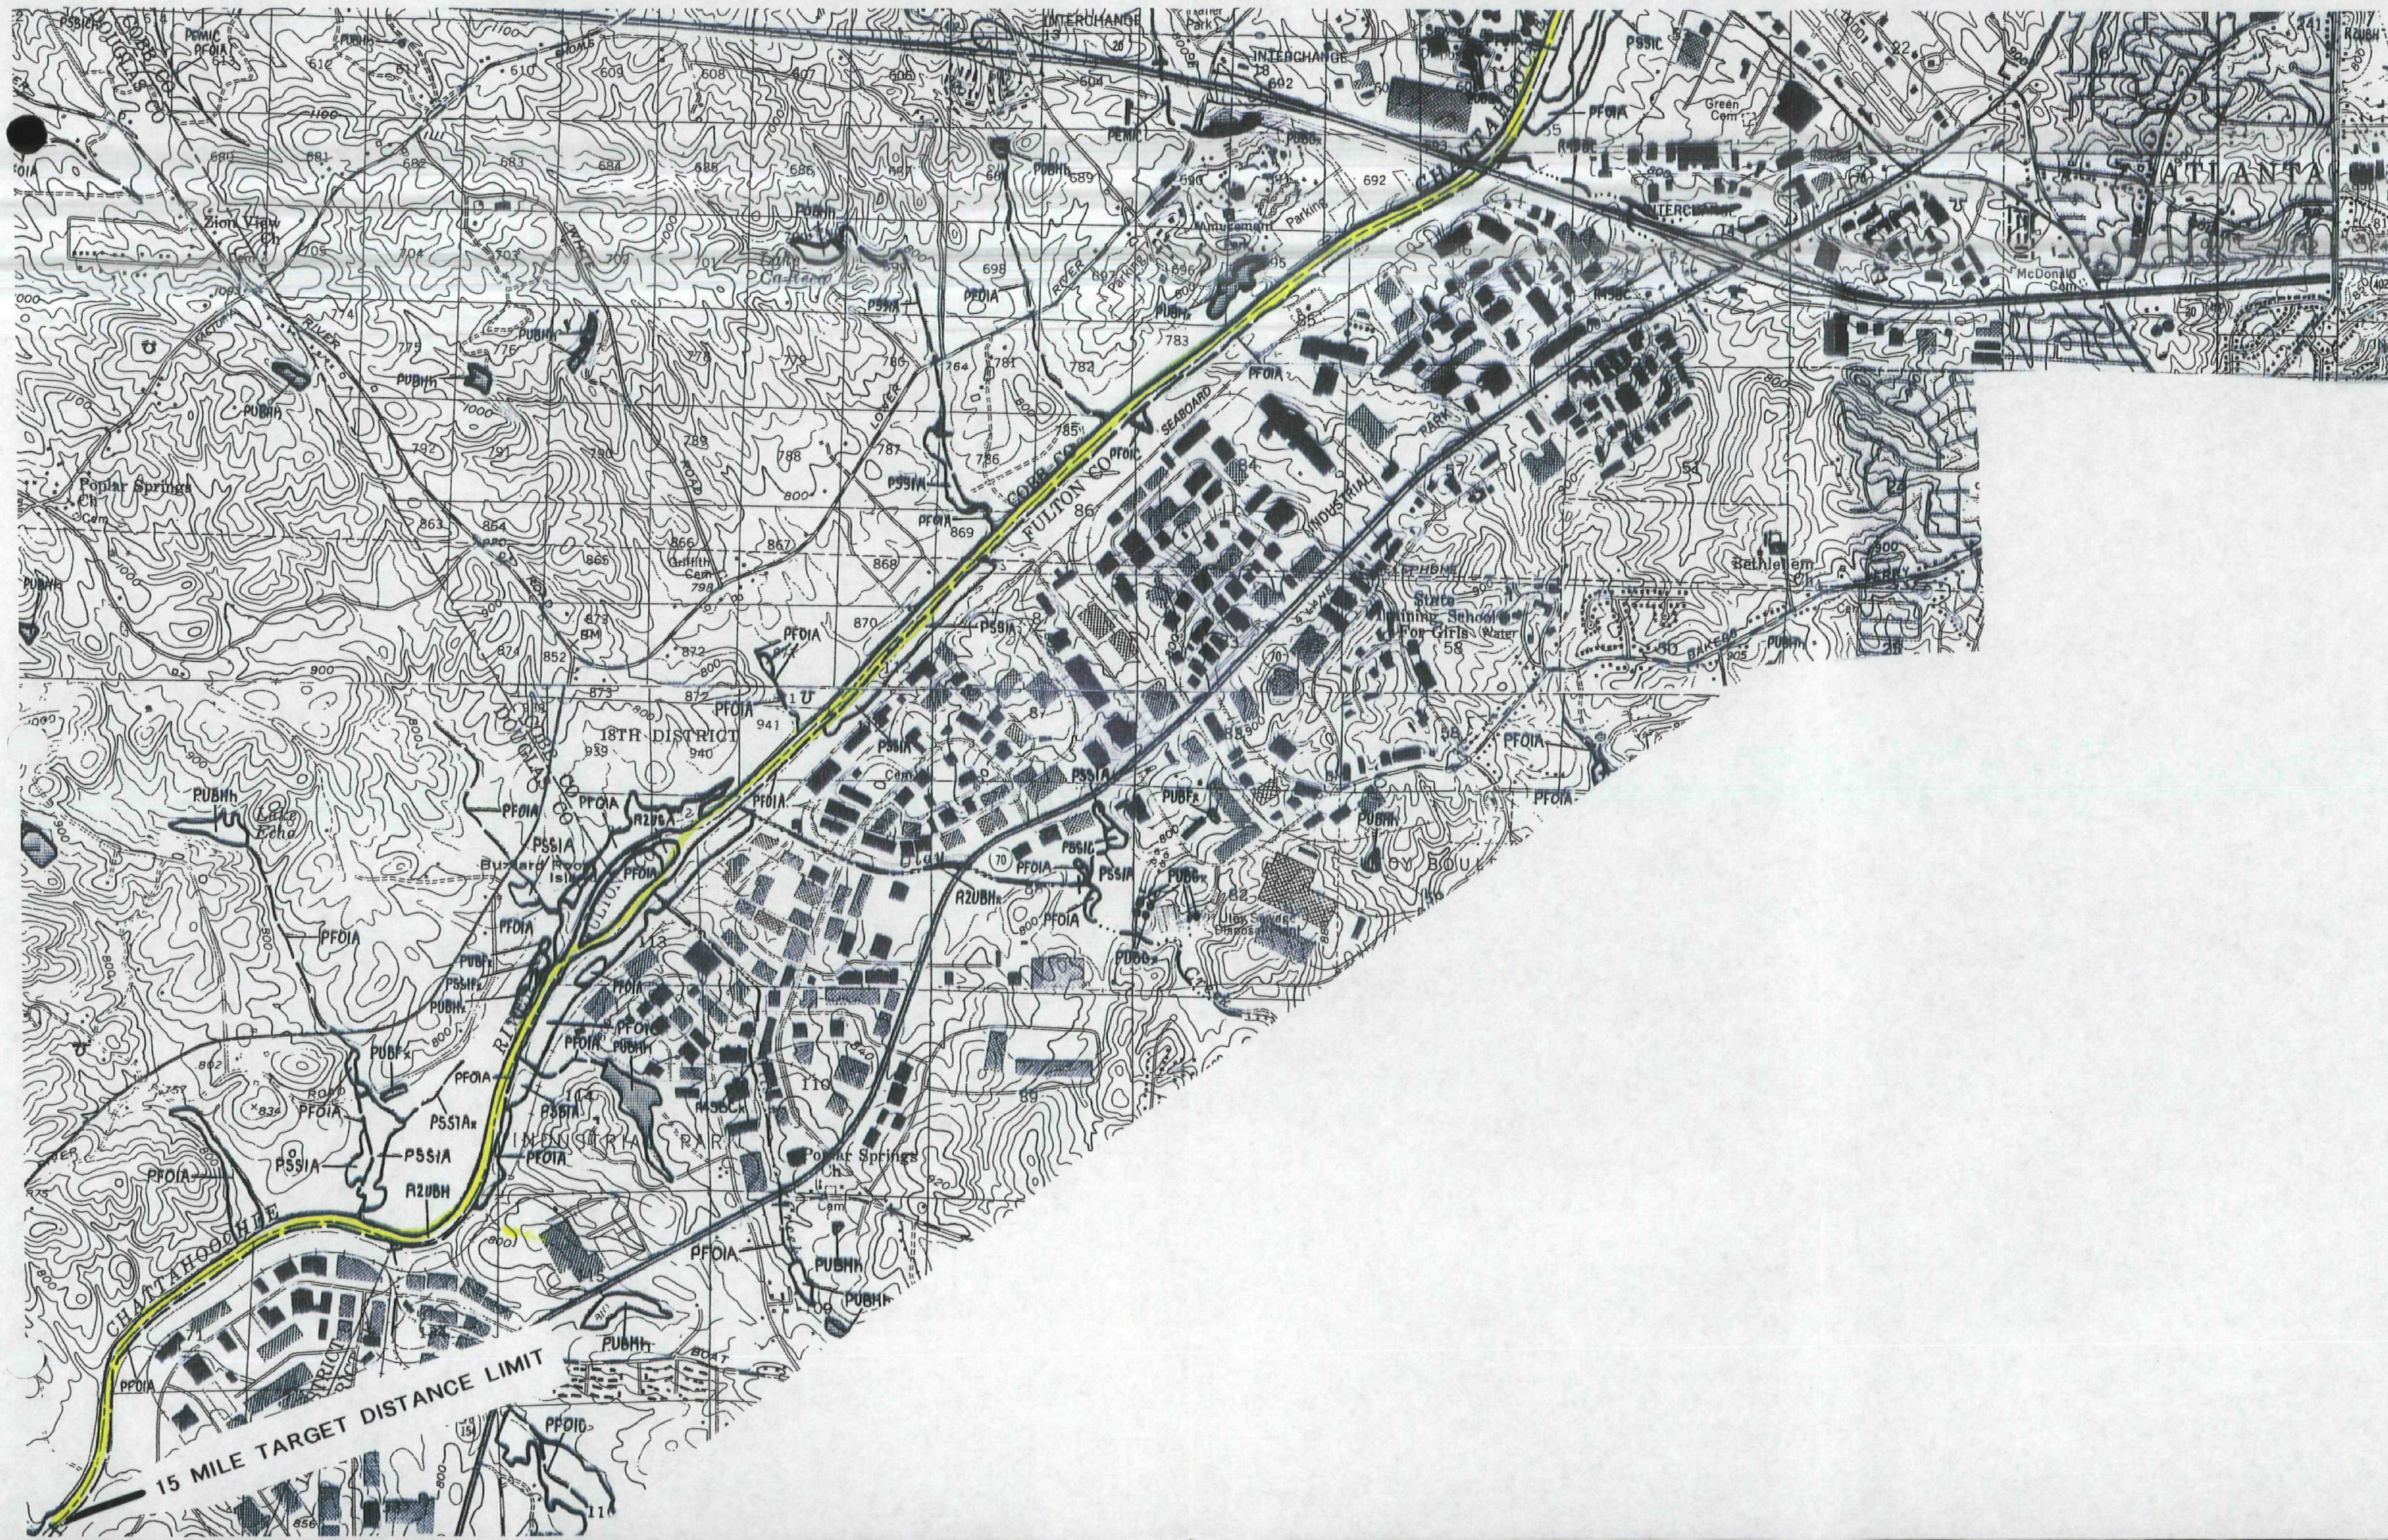
PA FIGURE 4.
WETLAND INVENTORY MAP
SHOWING SURFACE WATER PATHWAY
(REF. 31)

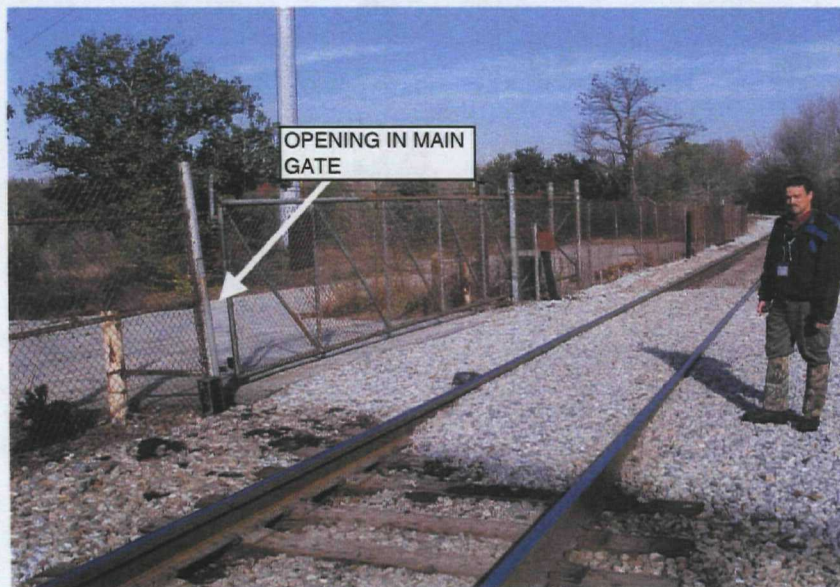
Photo No.	File Name	Time	Date	Bearing	Latitude (Degrees N)	Longitude (Degrees W)	
6	32	11:14 AM	11/29/2007	NW	-	-

Description: EASTERN GATE. NOTE GAP ON END OF GATE AND LACK OF NO TRESPASSING SIGN.

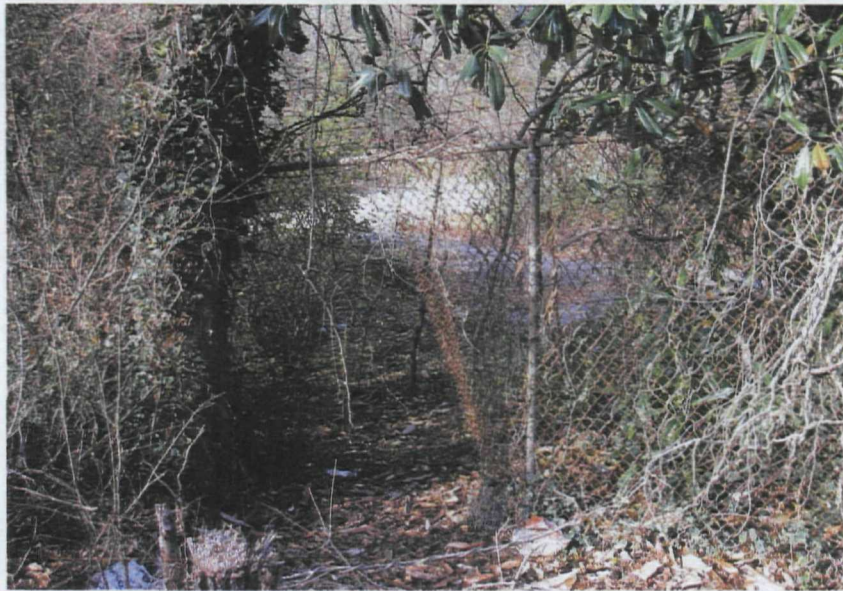
Photo No.	File Name	Time	Date	Bearing	Latitude (Degrees N)	Longitude (Degrees W)	
7	33	11:15 AM	11/29/2007	W	-	-

Description: HOLE IN FENCE LOCATED SEVERAL FEET SOUTH OF EASTERN FACILITY GATE

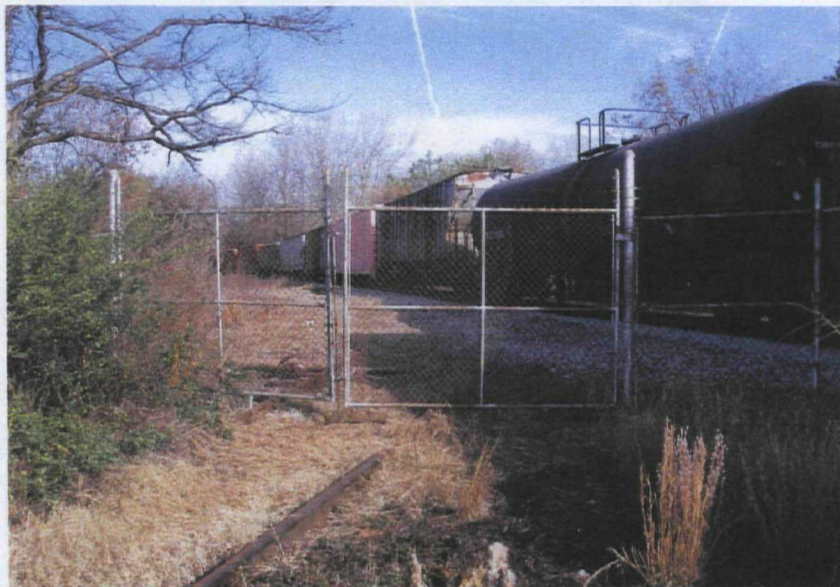
Photo No.	File Name	Time	Date	Bearing	Latitude (Degrees N)	Longitude (Degrees W)	
8	34	11:19 AM	11/29/2007	NE	-	-

Description: UNLOCKED RAILROAD GATE LOCATED SEVERAL FEET NORTH OF MAIN EASTERN FACILITY GATE.

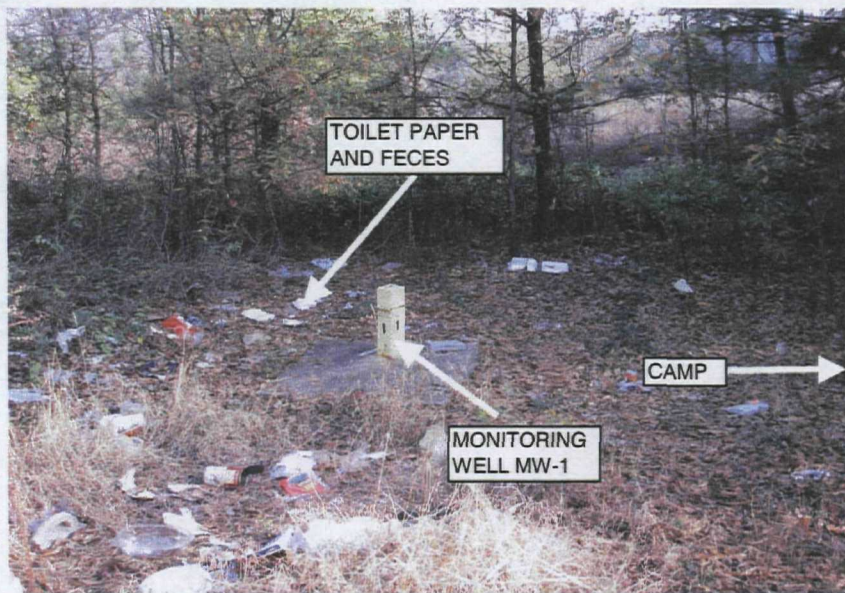
Photo No.	File Name	Time	Date	Bearing	Latitude (Degrees N)	Longitude (Degrees W)	
11	37	11:23 AM	11/29/2007	E	-	-

Description: FACILITY BACKGROUND MONITORING WELL LOCATED APPROXIMATELY 20 FEET NORTH OF INDIGENT EMCAMPMENT. INDIGENTS ARE USING THE AREA AS A LATRINE (NOTE TOILET PAPER).

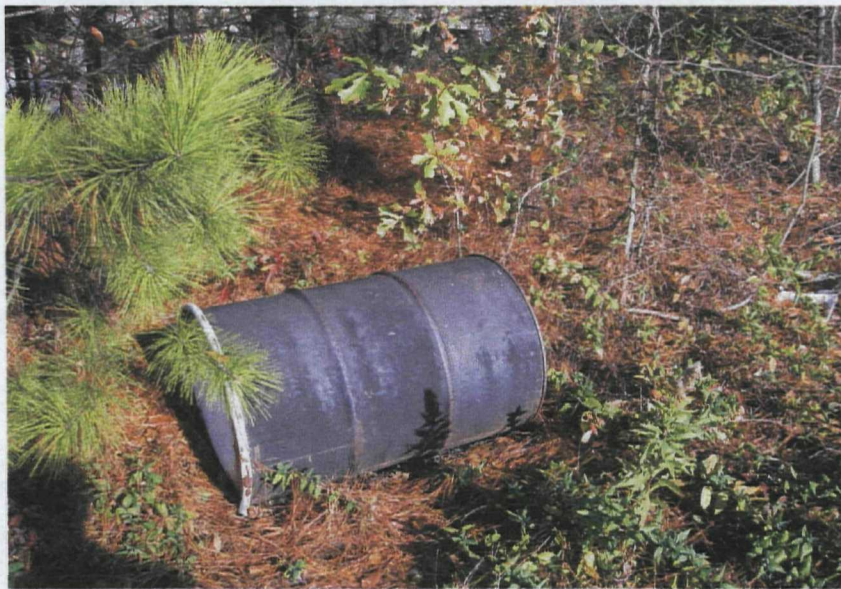
Photo No.	File Name	Time	Date	Bearing	Latitude (Degrees N)	Longitude (Degrees W)	
12	38	11:26 AM	11/29/2007	NW	33.7761	84.4277

Description: PROBABLE SOURCE. DRUM CONTAINING SOLID MATERIAL ACCORDING TO PREVIOUS INSPECTION REPORT

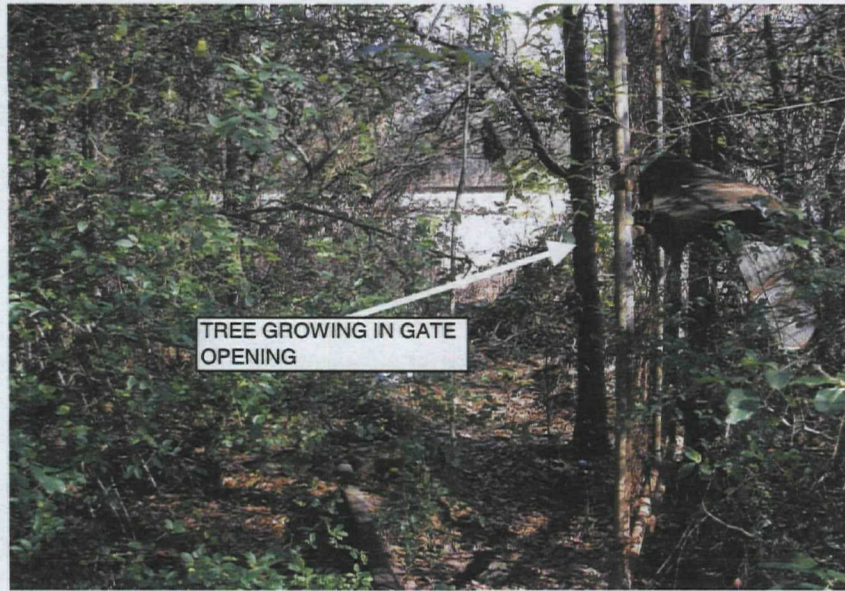
Photo No.	File Name	Time	Date	Bearing	Latitude (Degrees N)	Longitude (Degrees W)	
15	41	11:36 AM	11/29/2007	E	33.77666	84.4272

Description: OPEN GATE ON EAST SIDE OF FACILITY LOCATED NORTH OF MAIN GATE.

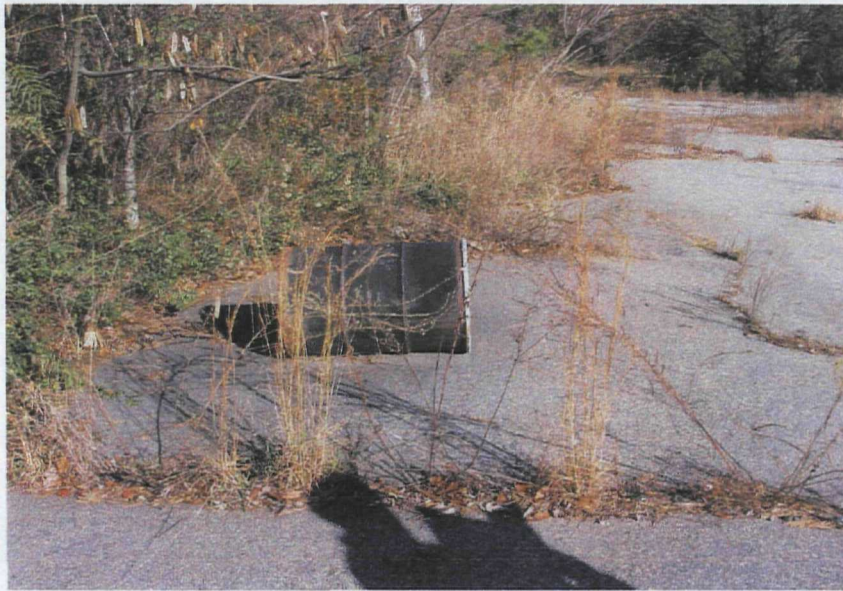
Photo No.	File Name	Time	Date	Bearing	Latitude (Degrees N)	Longitude (Degrees W)	
17	43	39,415	11/29/2007	N	33.77665	84.42822	
Description: PROBABLE SOURCE. DRUM CONTAINING SOLIDS ACCORDING TO PREVIOUS INSPECTION REPORT.

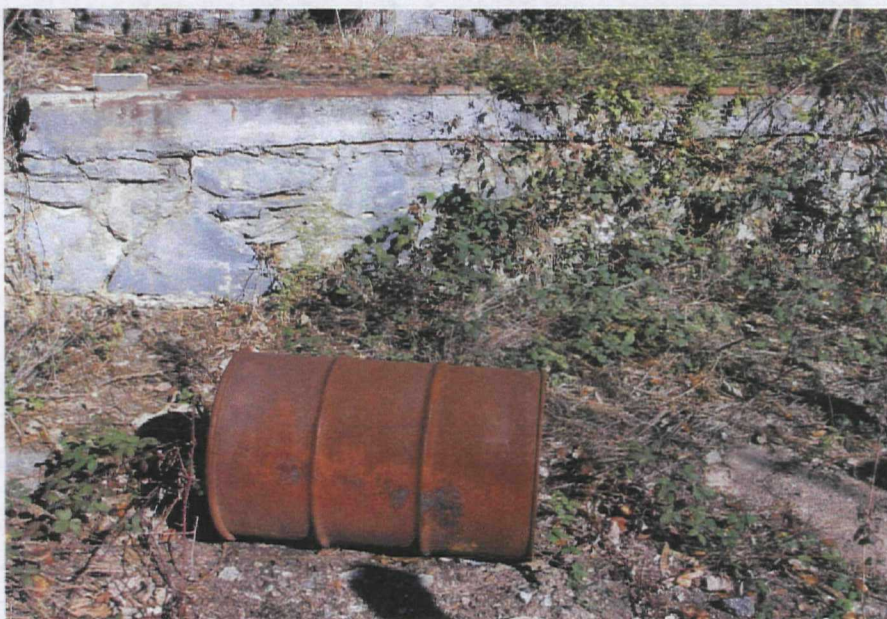
Photo No.	File Name	Time	Date	Bearing	Latitude (Degrees N)	Longitude (Degrees W)	
33	59	1:56 PM	11/29/2007	N	33.77495	84.42732

Description: PROBABLE SOURCE. OVERTURNED DRUM WITH APPARENT SALTS ON OUTSIDE.

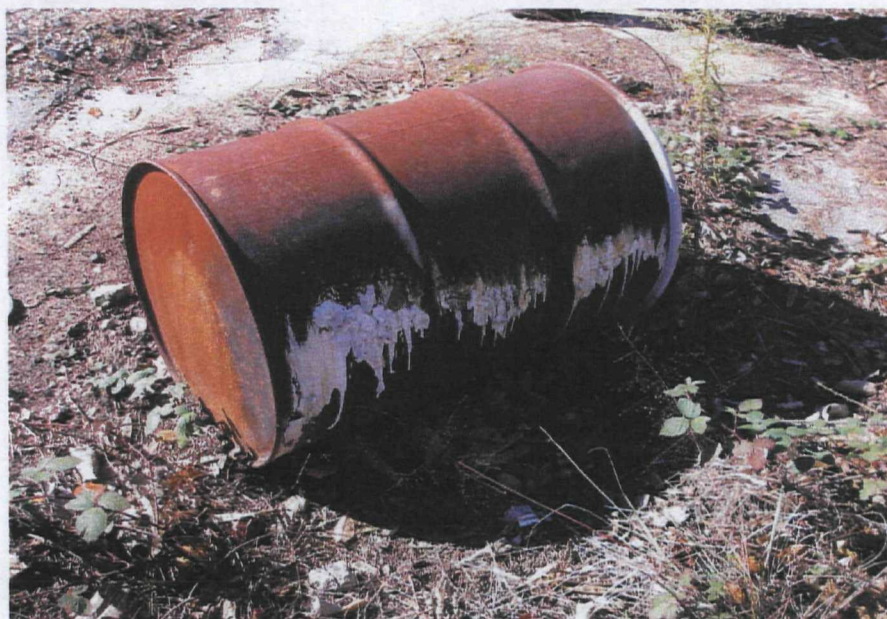
Photo No.	File Name	Time	Date	Bearing	Latitude (Degrees N)	Longitude (Degrees W)	
34	60	1:59 PM	11/29/2007	SW	33.77495	84.42732

Description: PROBABLE SOURCE. OVERTURNED DRUM WITH APPARENT SALTS ON OUTSIDE.

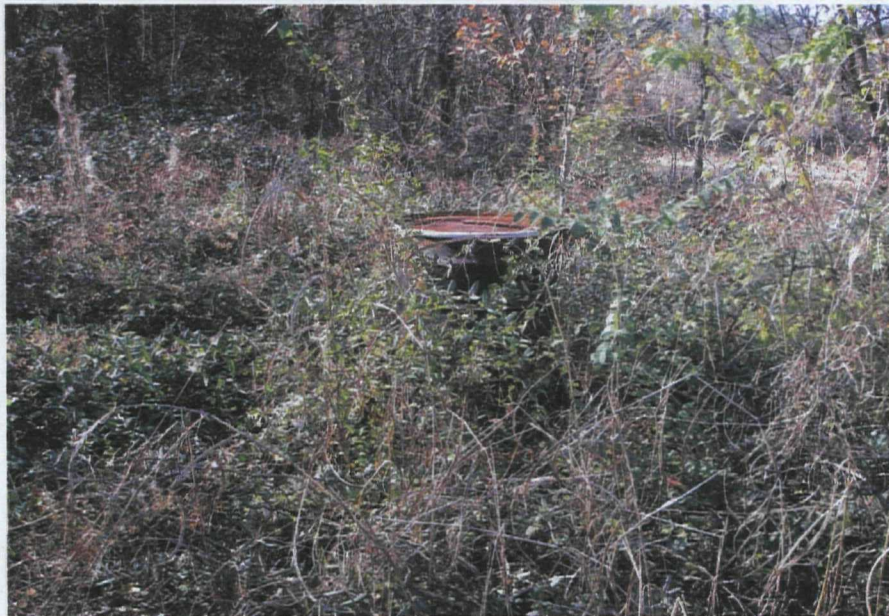
Photo No.	File Name	Time	Date	Bearing	Latitude (Degrees N)	Longitude (Degrees W)	
36	62	2:06 PM	11/29/2007	W	33.77478	84.4278

02	2017-01-11	11/23/2017	11	CONFIDENTIAL
Description: PROBABLE SOURCE. DRUM WITH UNKNOWN CONTENTS.

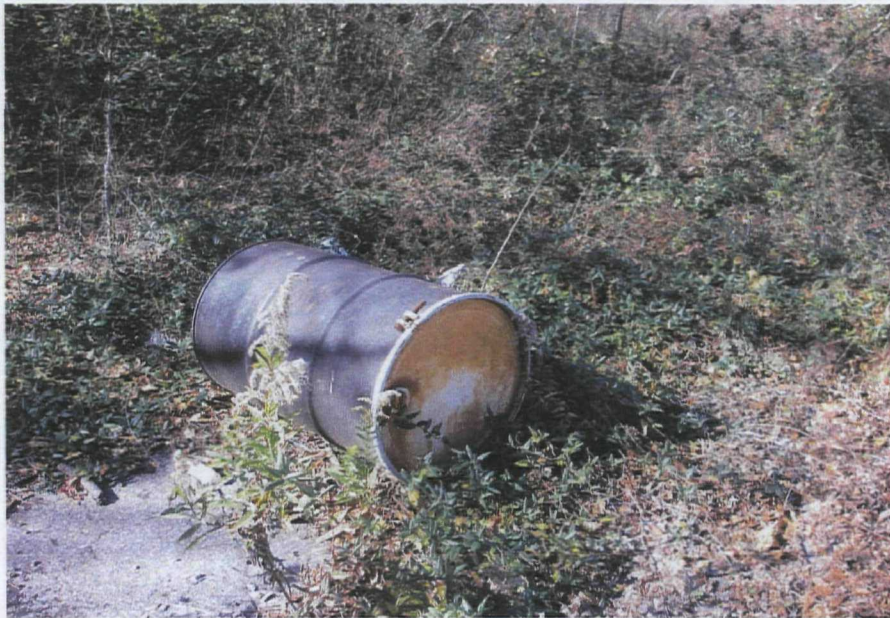
Photo No.	File Name	Time	Date	Bearing	Latitude (Degrees N)	Longitude (Degrees W)	
37	63	2:06 PM	11/29/2007	NW	33.7751	84.42788

Description: PROBABLE SOURCE. DRUM THAT ACCORDING TO TOM BRODELL CONTAINS SOLIDS. LOCATED NEAR MW-13.

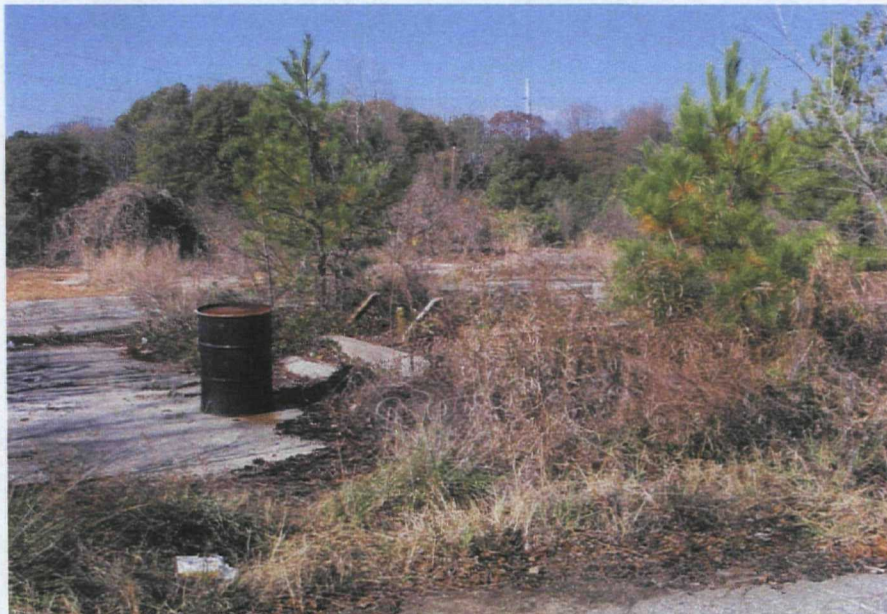
Photo No.	File Name	Time	Date	Bearing	Latitude (Degrees N)	Longitude (Degrees W)	
38	64	2:12 PM	11/29/2007	N	33.77541	84.42803

Description: PROBABLE SOURCE. DRUM THAT CONTAINS SOLIDS ACCORDING TO TOM BRODELL.

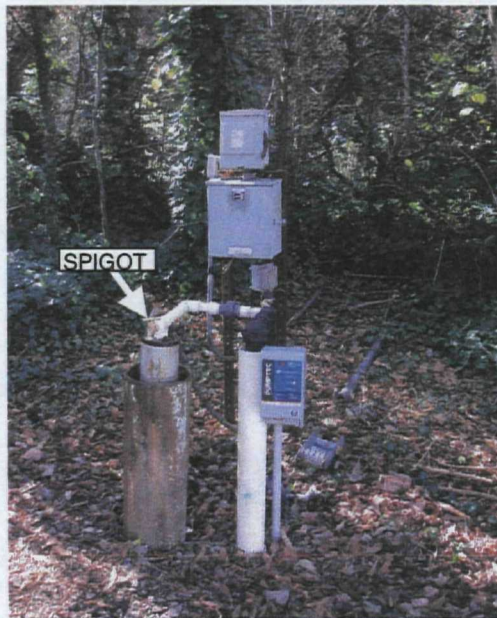
Photo No.	File Name	Time	Date	Bearing	Latitude (Degrees N)	Longitude (Degrees W)	
45	71	10:07 AM	11/30/2007	W	-	-

Description:	RECOVERY WELL RW-4 LOCATED SOUTHWEST OF REMEDIATION BUILDING. WELL HAS ELECTRICITY AND IS RUNNING. WELL HAS A SPIGOT THAT PRODUCED WATER WHEN PUMP AUTOMATICALLY TURNED ON. AREA AROUND WELL IS CLEARED/TRAMPLED AND A FOOTPATH IS NEARBY (SEVERAL FEET). INDIGENTS MAY BE USING WATER FROM SPIGOT.
--------------	---

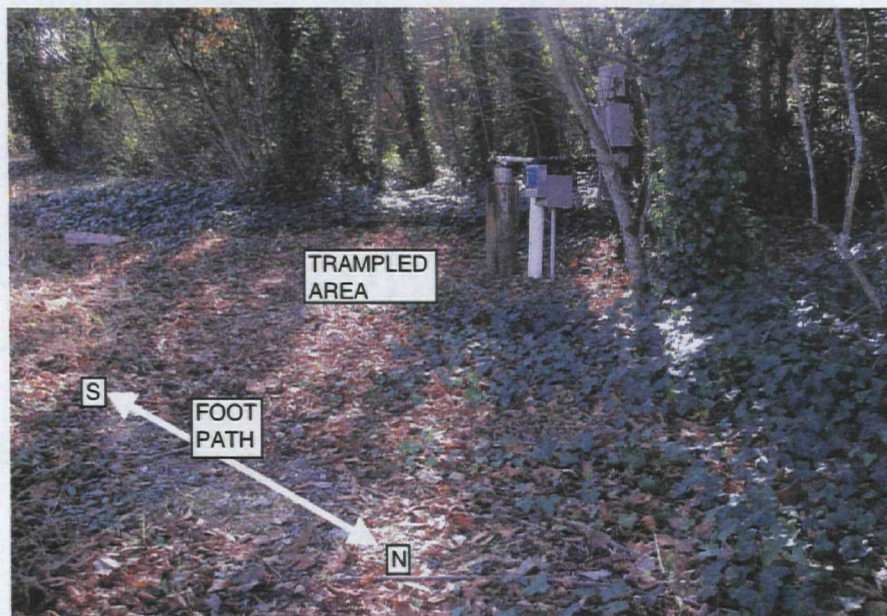
Photo No.	File Name	Time	Date	Bearing	Latitude (Degrees N)	Longitude (Degrees W)	
46	72	2:50 PM	11/29/2007	SW	-	-

72	2:00 PM	11/26/2007
Description: RECOVERY WELL RW-4.

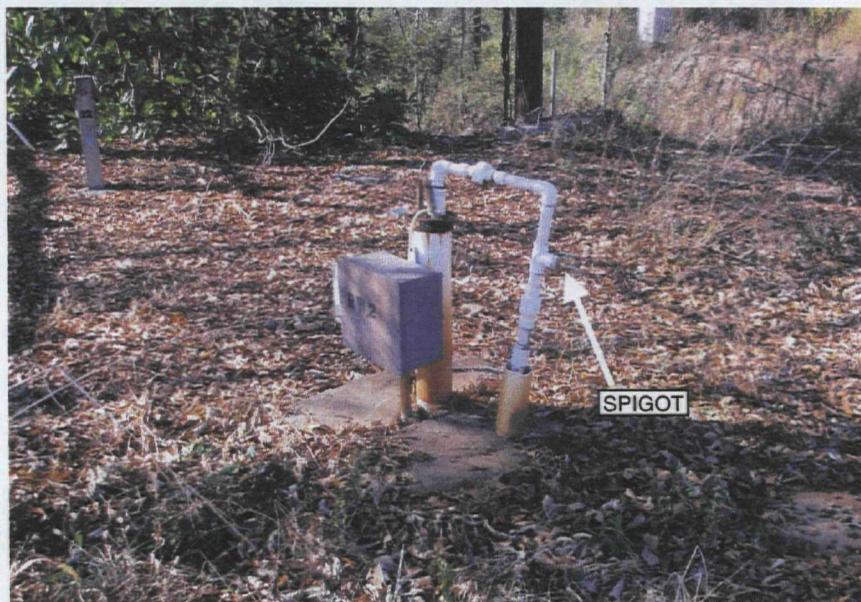
Photo No.	File Name	Time	Date	Bearing	Latitude (Degrees N)	Longitude (Degrees W)	
66	92	3:17 PM	11/29/2007	W	-	-	
Description: RECOVERY WELL RW-2. NOTE SPIGOT. NOT RUNNING. CIRCUIT BREAKER LIGHT INDICATES BREAKER IS TRIPPED BUT POWER ON.

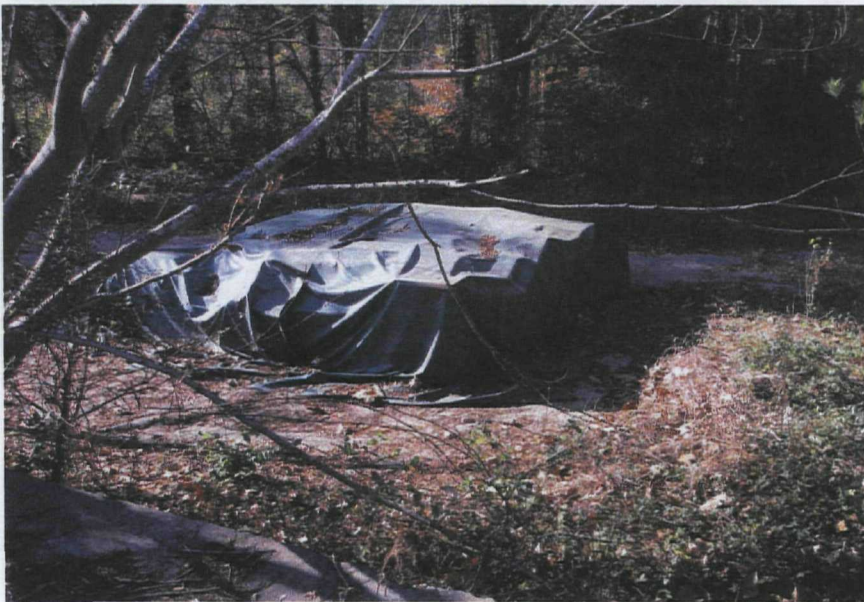
Description: TARP COVERING UNKNOWN ITEMS ON WESTERN PORTION OF SITE NEAR INDIGENT CAMP.

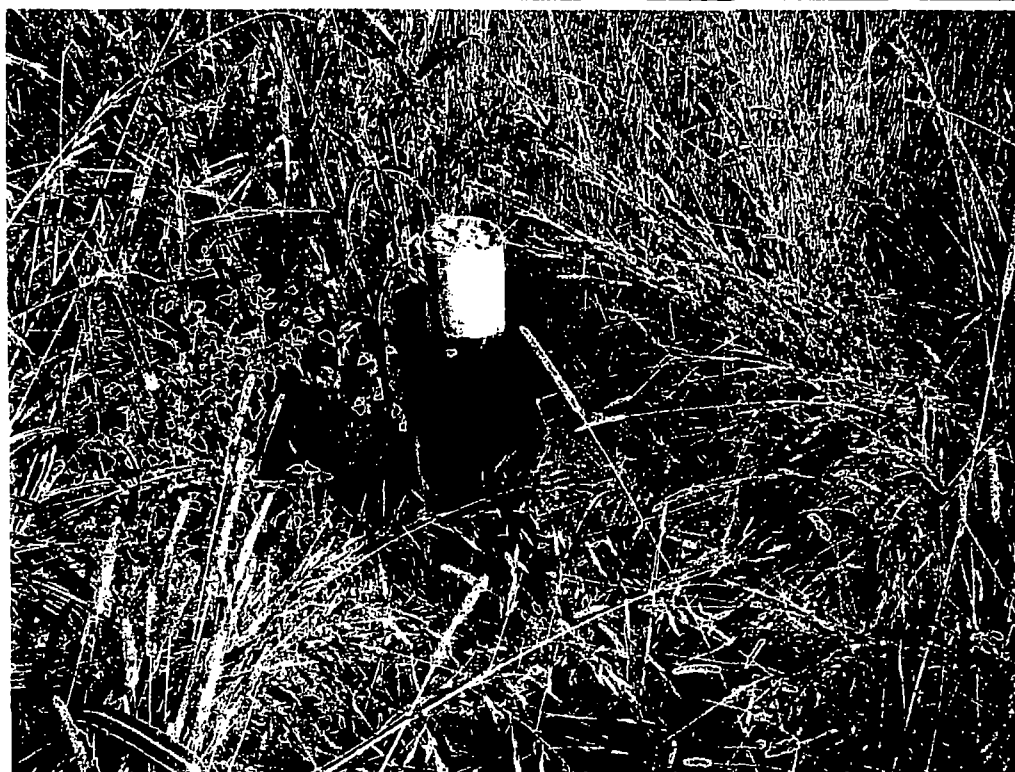
Photo	6 of 45	Date:	09/24/2007	Site Name:	AZS Corporation		
Photographer:	Thomas J Brodell, QEP; HWMB			City:	Atlanta	County:	Fulton
Explanation:	RW-1 found without lock or well housing cover, located downgradient of Polymer Pond HWMU. Well was not labeled.

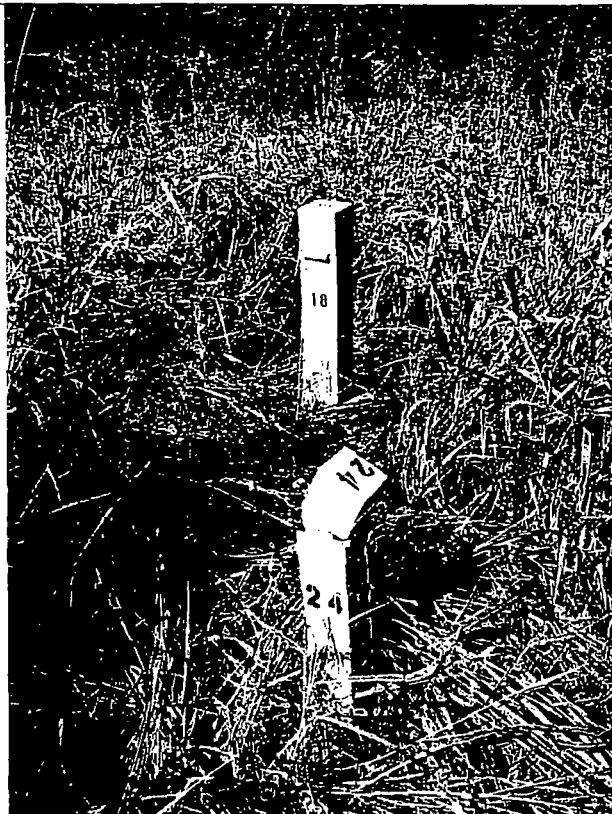
Photo	7 of 45	Date:	09/24/2007	Site Name:	AZS Corporation		
Photographer:	Thomas J Brodell, QEP; HWMB			City:	Atlanta	County:	Fulton
Explanation:	MW-24 (foreground) and MW-18(background), downgradient of the Polymer Pond HWMU. Protective Casing Cap for MW-24 found as pictured and unable to close fully. Both wells were found without a lock.

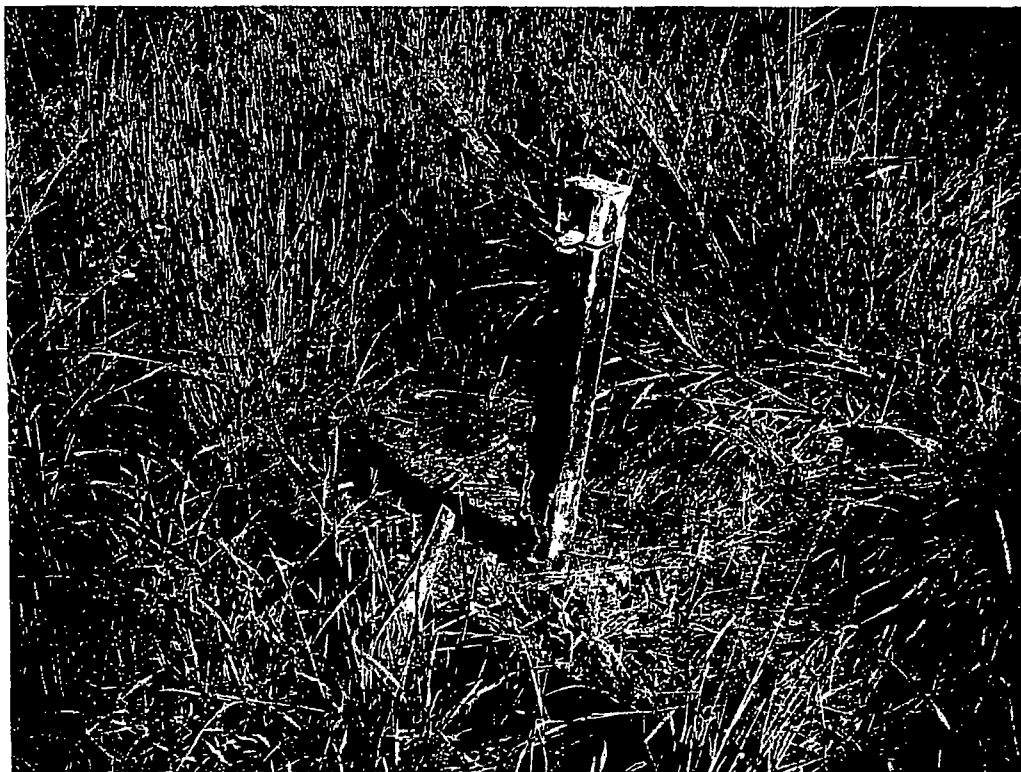
Photo	20 of 45	Date:	09/24/2007	Site Name:	AZS Corporation		
Photographer:	Thomas J Brodell, QEP; HWMB			City:	Atlanta	County:	Fulton
Explanation:	MW-2, Point Of Compliance Well for Polymer Pond. Pad is lifted and damaged. Well and casing above ground is slanted toward right of photo.

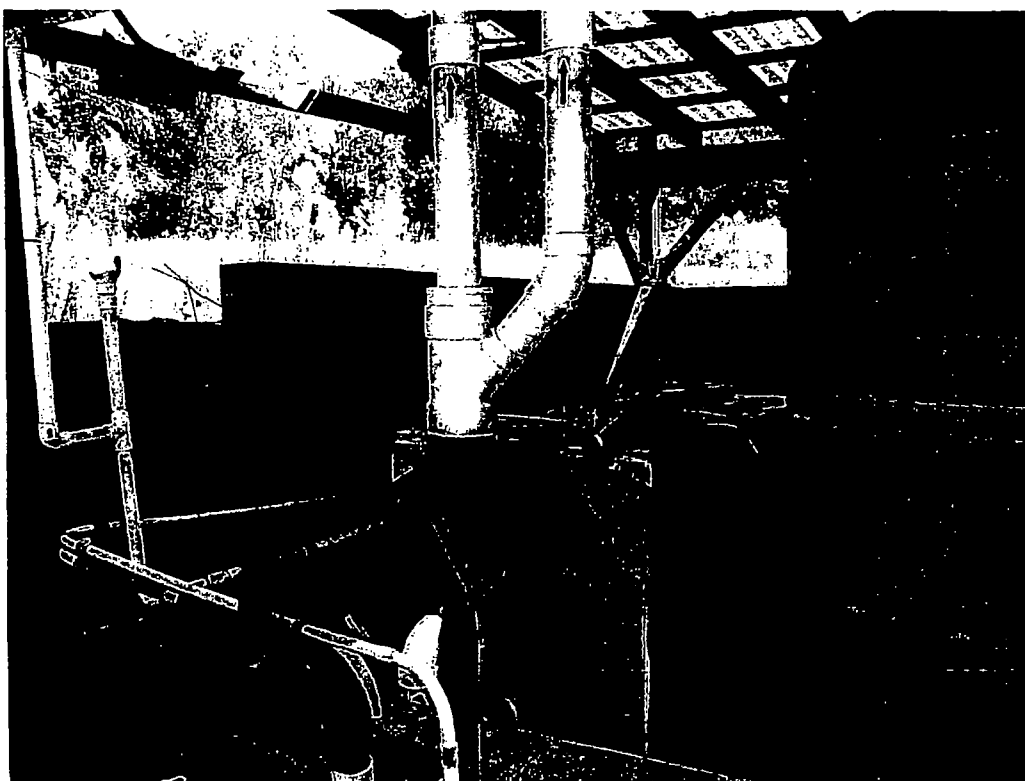
Photo	25 of 45	Date:	09/24/2007	Site Name:	AZS Corporation		
Photographer:	Thomas J Brodell, QEP; HWMB			City:	Atlanta	County:	Fulton
Explanation:	Second view of groundwater treatment system. System is not currently operational due to theft of copper electrical wiring.

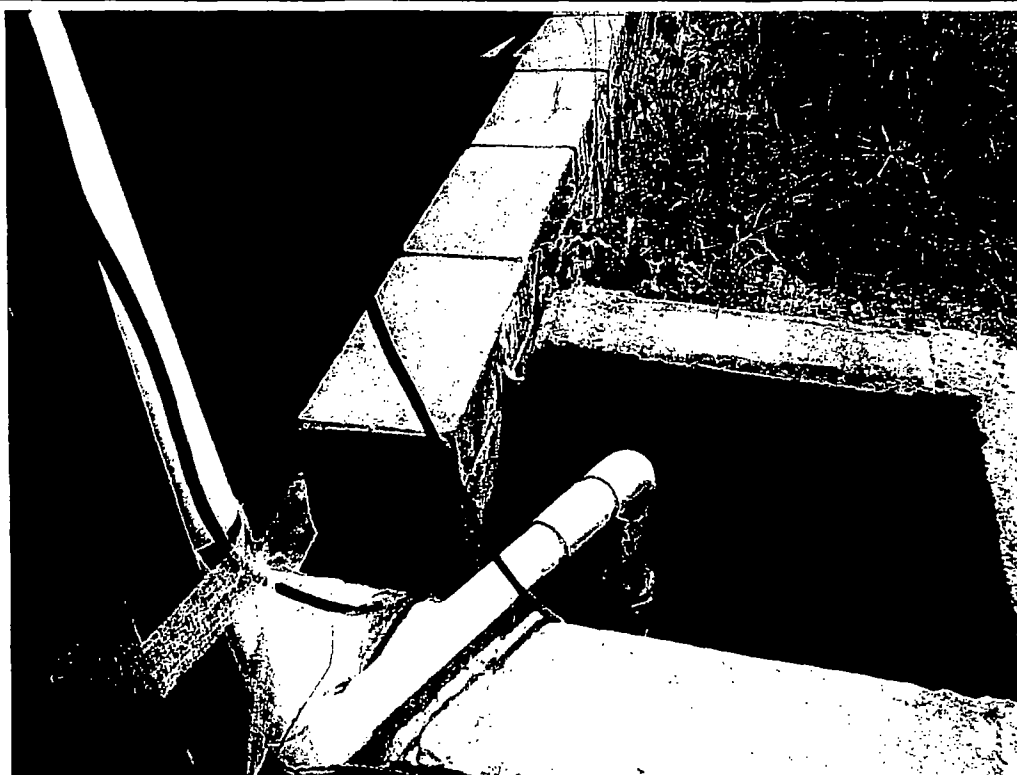
Photo	30 of 45	Date:	09/24/2007	Site Name:	AZS Corporation		
Photographer:	Thomas J Brodell, QEP; HWMB			City:	Atlanta	County:	Fulton
Explanation:	Sump to collect stormwater contacting groundwater treatment system. Note attempt to repair concrete blocks pulling away from wall. Caulking compound observed to be withered and shrunk. Sump intended to pump stormwater into treatment system.

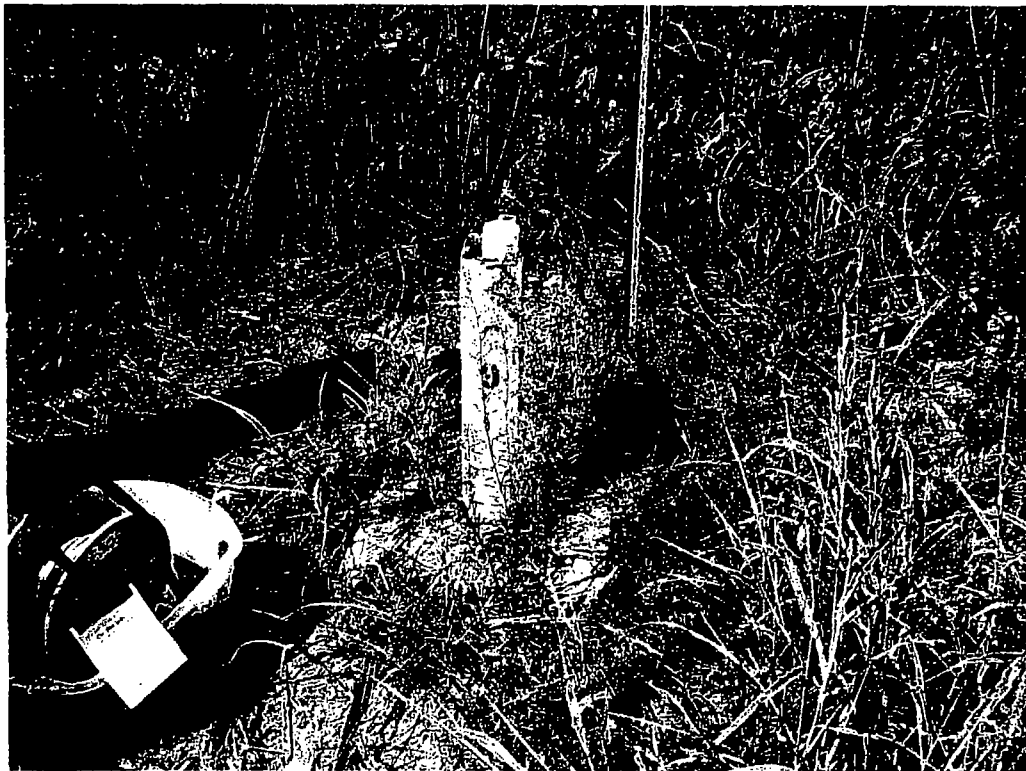
Photo	32 of 45	Date:	09/24/2007	Site Name:	AZS Corporation		
Photographer:	Thomas J Brodell, QEP; HWMB			City:	Atlanta	County:	Fulton
Explanation:	MW-9 at southeastern corner of former Truck Lot, found without lock.

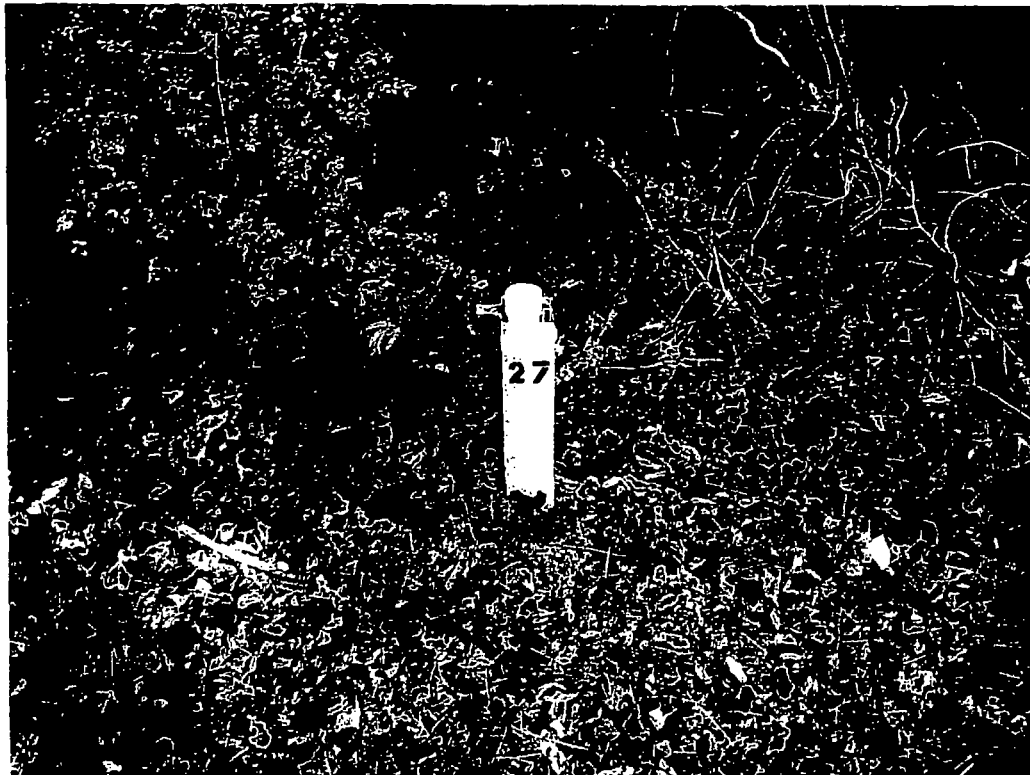
Photo	35 of 45	Date:	09/24/2007	Site Name:	AZS Corporation		
Photographer:	Thomas J Brodell, QEP; HWMB			City:	Atlanta	County:	Fulton
Explanation:	MW-27 found without lock and without protective casing cap.

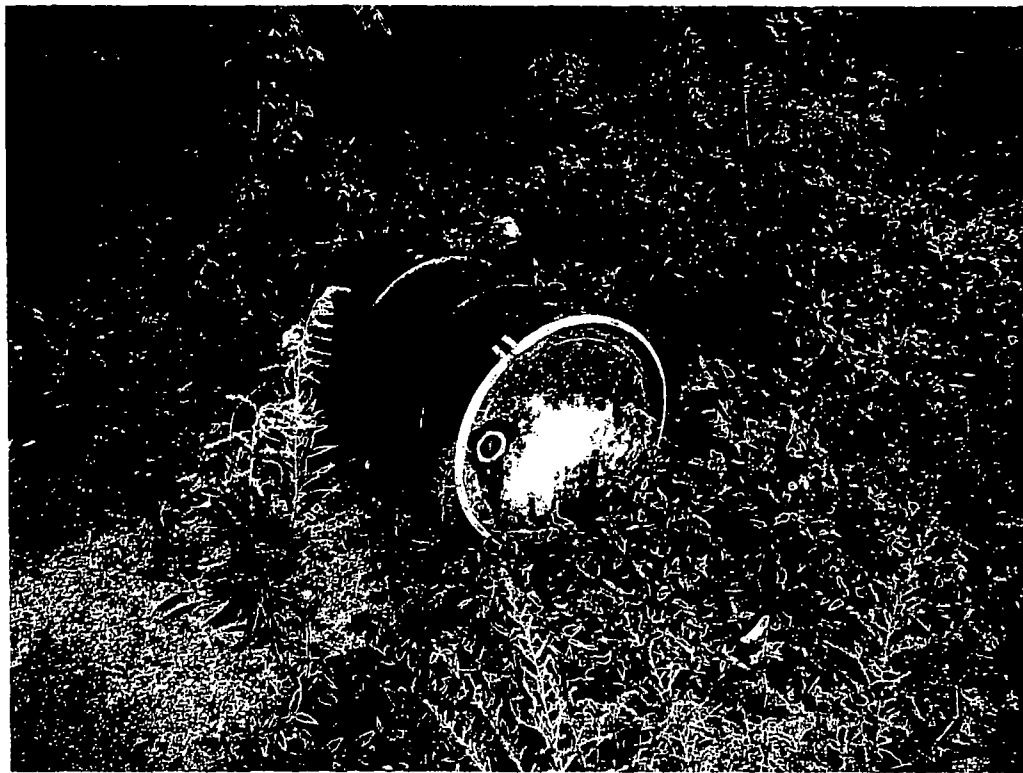
Photo	44 of 45	Date:	09/24/2007	Site Name:	AZS Corporation		
Photographer:	Thomas J Brodell, QEP; HWMB			City:	Atlanta	County:	Fulton
Explanation:	55-gallon drum of solids near MW-13.

Seven drums were observed on-site, five of them apparently filled with solids (see Photo #s 03, 04, 21, 22, 43, 44 and 45). One drum (see Photo # 43) exhibited clear evidence of corrosion and salt formation on the outside of the drum. Except for one drum, no labeling was observed, and the one labeled drum was illegible. These drums were all observed on areas of the facility owned by United Real Property. According to Mr. Hill, United Real Property conducted soil borings in 2004, and he believed the drums might be from that activity. Review of the Inspection Logs, during the Records Review, however, indicated that United conducted soil excavations, not borings.

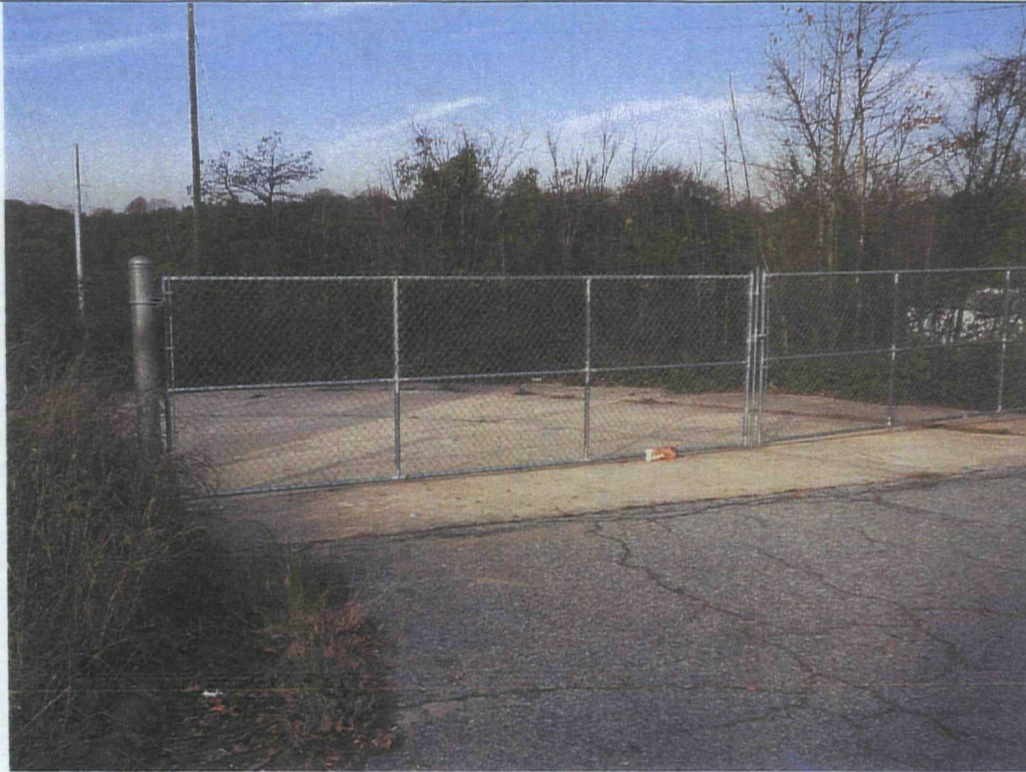
Photo	01 of 43	Date:	11/29/07	Site Name:	AZS Corporation		
Photographer:	Thomas J Brodell, QEP; HWMB			City:	Atlanta	County:	Fulton
Explanation:	Fence at Marietta Boulevard. Locked, but no signs and clearly worn footpaths observed present on each side of fence.

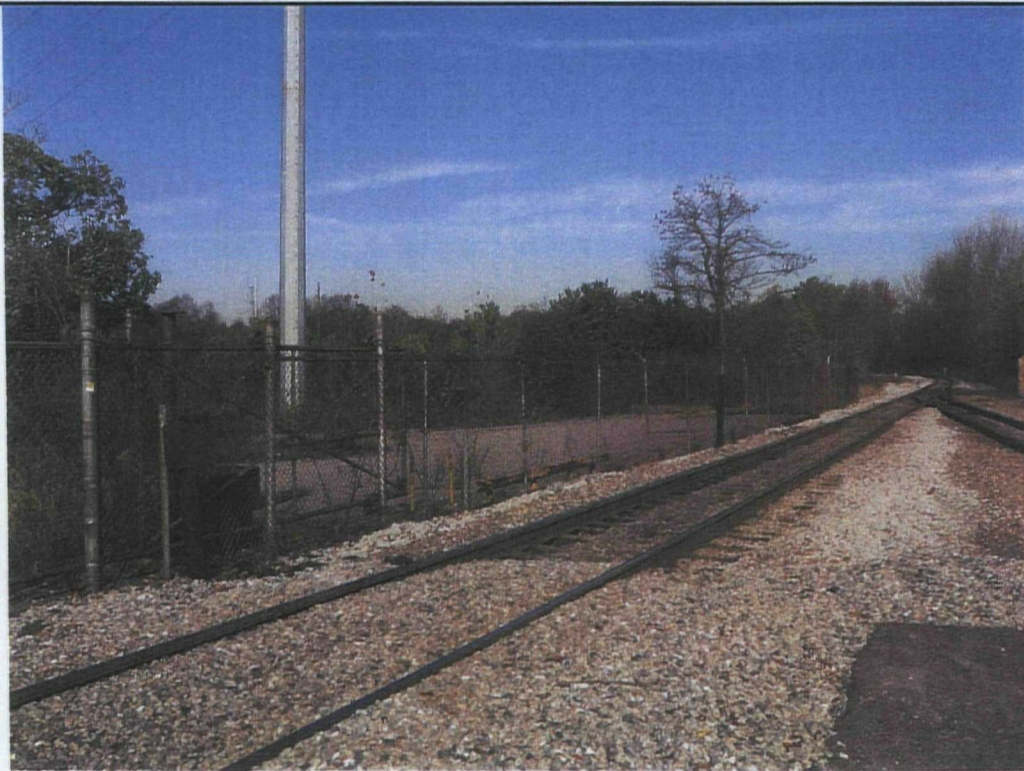
Photo	02 of 43	Date:	11/29/07	Site Name:	AZS Corporation		
Photographer:	Thomas J Brodell, QEP; HWMB			City:	Atlanta	County:	Fulton
Explanation:	Property-line fence, looking approximately NNW. No signs warning against trespass or entry.

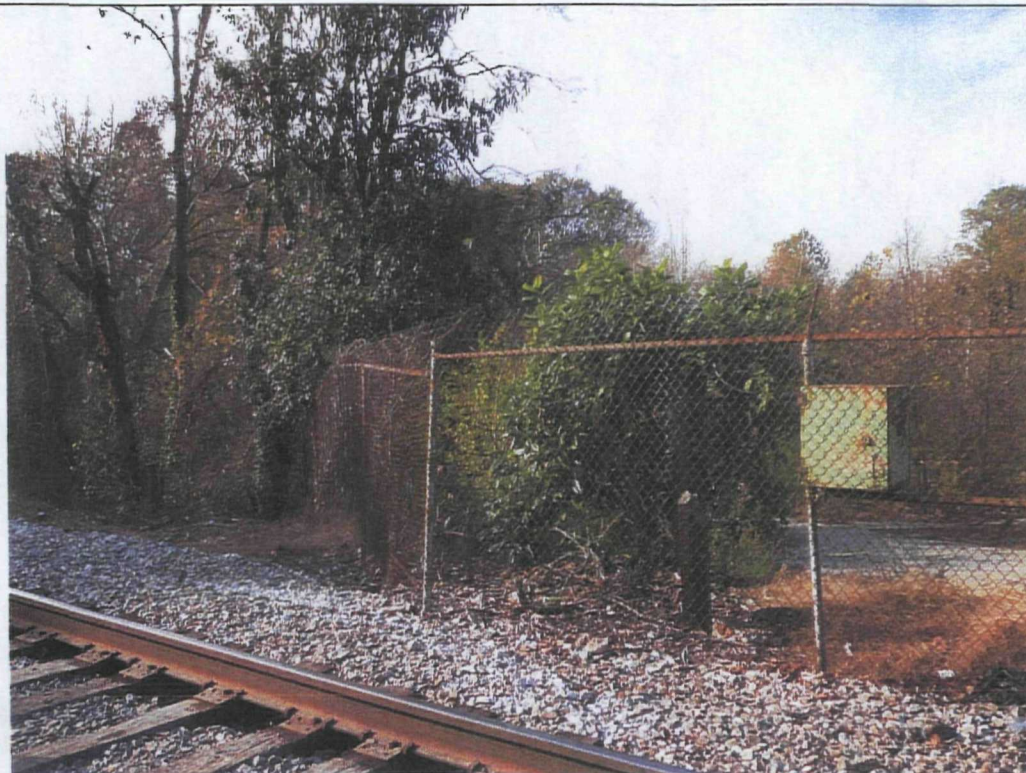
Photo	03 of 43	Date:	11/29/07	Site Name:	AZS Corporation		
Photographer:	Thomas J Brodell, QEP; HWMB			City:	Atlanta	County:	Fulton
Explanation:	Property-line fence, looking approximately WSW. No signs warning against trespass or entry. Fence on left side of photo has foot path and hole.
